ONDERZOEKSRaad
VOOR VEILIGHEID

Mortierongeval Mali 2016

Heropening onderzoek 2022

Den Haag, augustus 2022

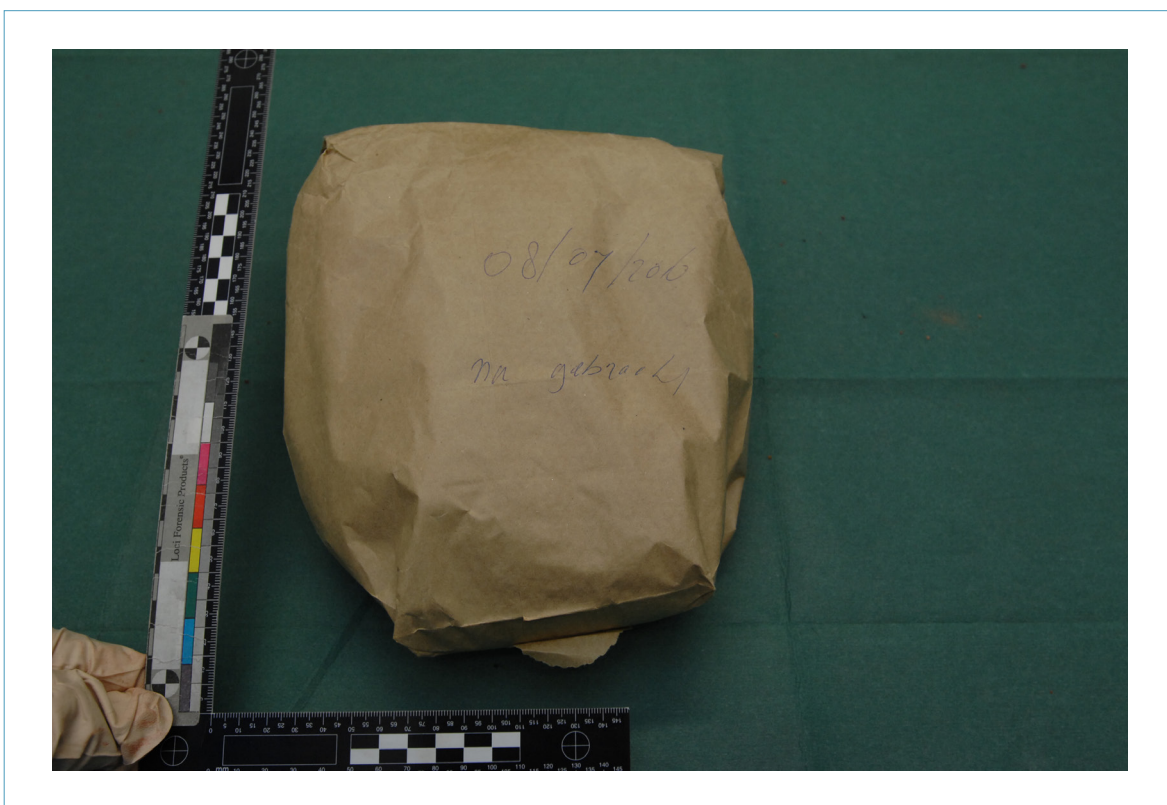
Figuur 1: De op 8 juli 2016 in Gao nageleverde bruin papieren zak²¹

Uit deze gereconstrueerde gang van zaken kan worden opgemaakt dat de granaatscherven en restanten in de bruine zak, die op 8 juli 2016 is afgeleverd bij de KMar in Gao, niet anders geduid kunnen worden dan als de granaatscherven en restanten die op 6 juli 2016 zijn verzameld tijdens de zoekactie direct na het ongeval. Ook kan worden uitgesloten dat tijdens de zoekactie direct na het ongeval de granaatscherven van de vóór het ongeval vernietigde blindganger zijn opgeraapt. De blindganger was terecht gekomen op ongeveer 500 meter afstand van de ongevalslocatie zonder te detoneren. Het zoekgebied van de ongevalsgranaat op de ongevalslocatie besloeg 100x100 meter.

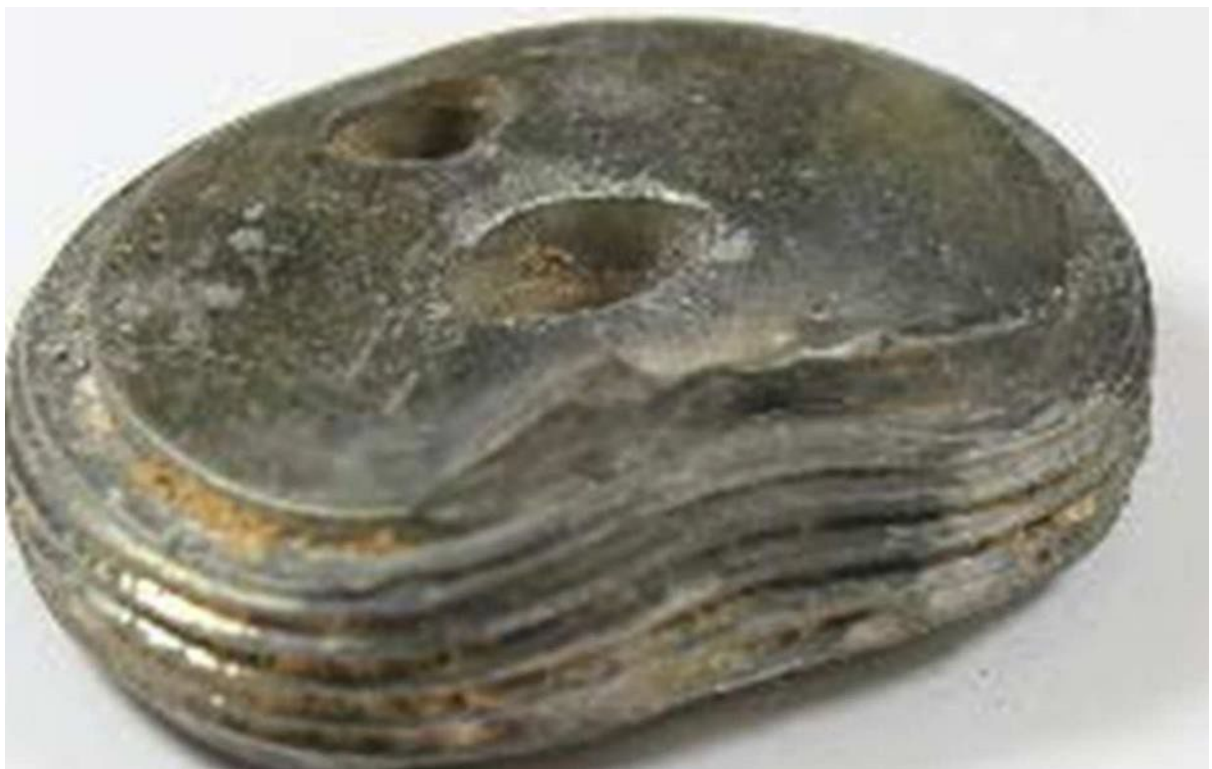
Figure 10: Enlargement of the cover plate shows possible presence of sand in the thread. (Picture: TNO)

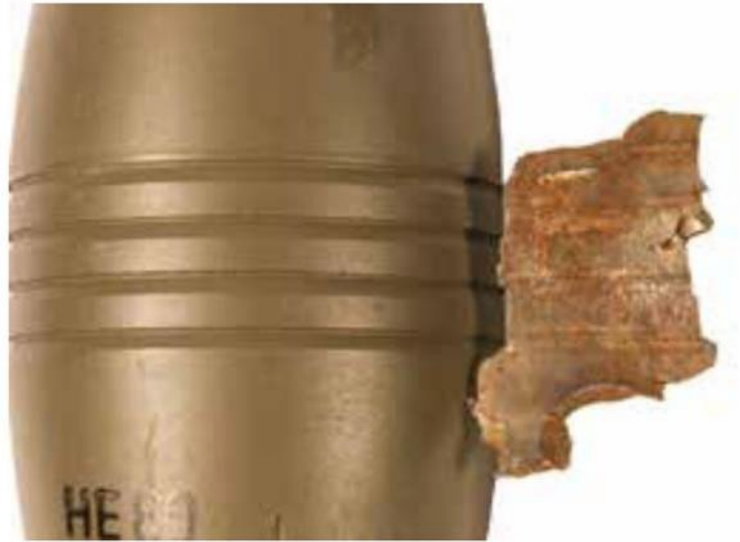
Figure 11: Imprint on the fragment of the launch tube, originating from the grooves on the shell casing when the main charge explodes. Figure illustrates the steel fragments produced during detonation of an HE 80 mortar round. (Picture: TNO)

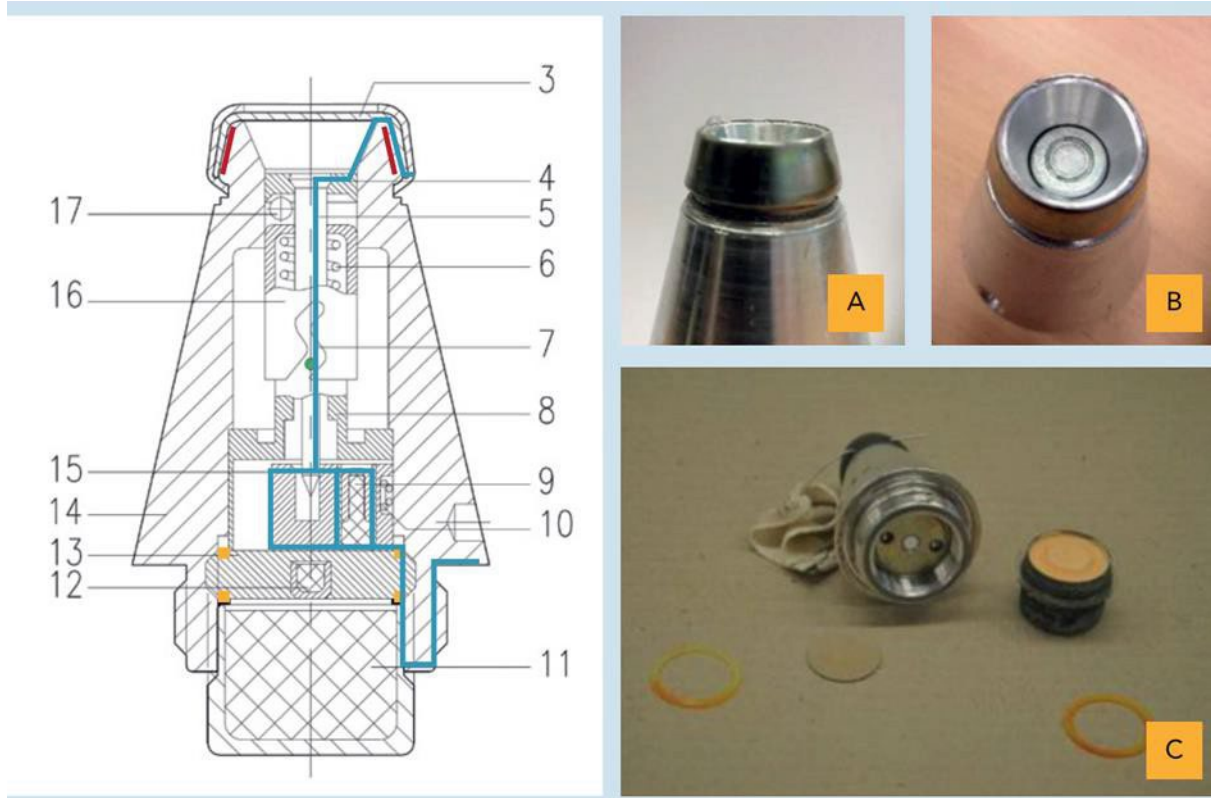
Figure 15: Cross section of the fuze with potential routes (blue) for moisture penetration via the adhesive layer (red) and sealing rings (yellow). Picture A: adhesive layer for the membrane, picture B: opening between the firing pin and the housing. Conclusion is that moisture ingress more likely via top of fuze. (Source: TNO)

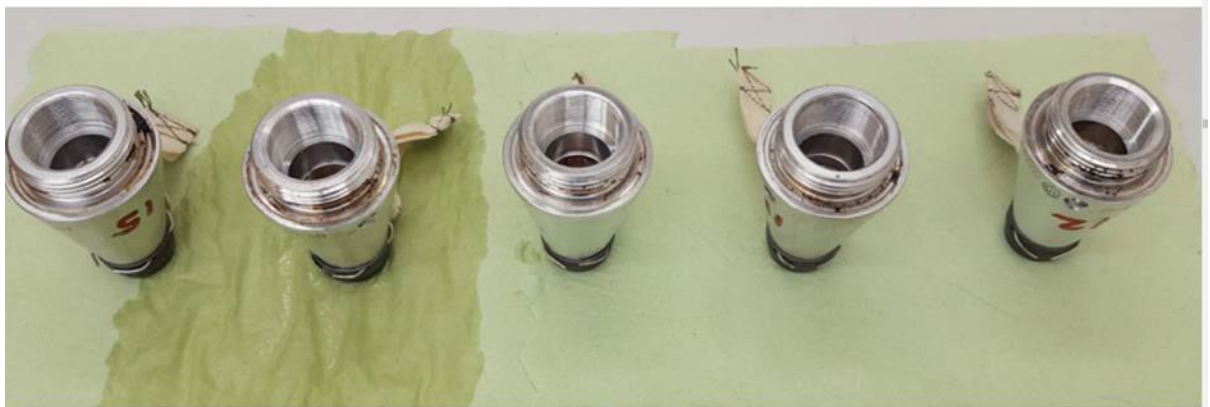
Figure 16: Filling the top of the M6-N fuze with water to show leakage. The adhesive layer of one of the five fuzes tested is leaking after a drop test from about one metre height with random impact orientation. (Picture: TNO)

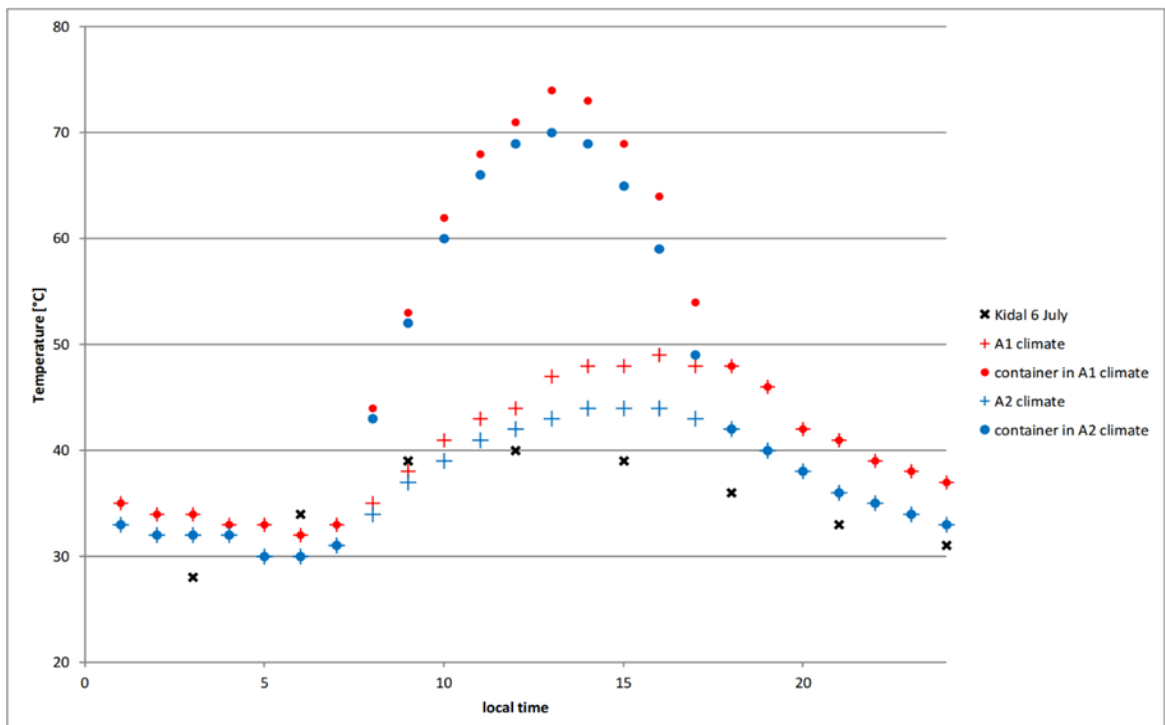
Figure 18: Expected temperature profile in Kidal storage container during the days around 6 July 2016. (Source: TNO)

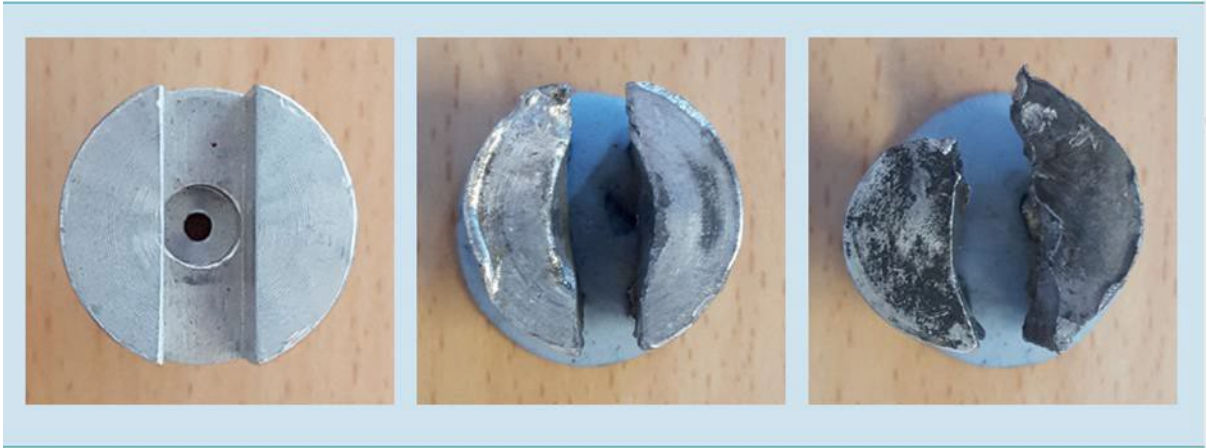
Figure 29: Bottom view of an unused firing pin housing (left), from the test in armed position (centre) and from the accident mortar round (right). The greater asymmetry in the accident round can be interpreted as reflecting the detonator being off-centre in the 'safe' position. (Picture: TNO)

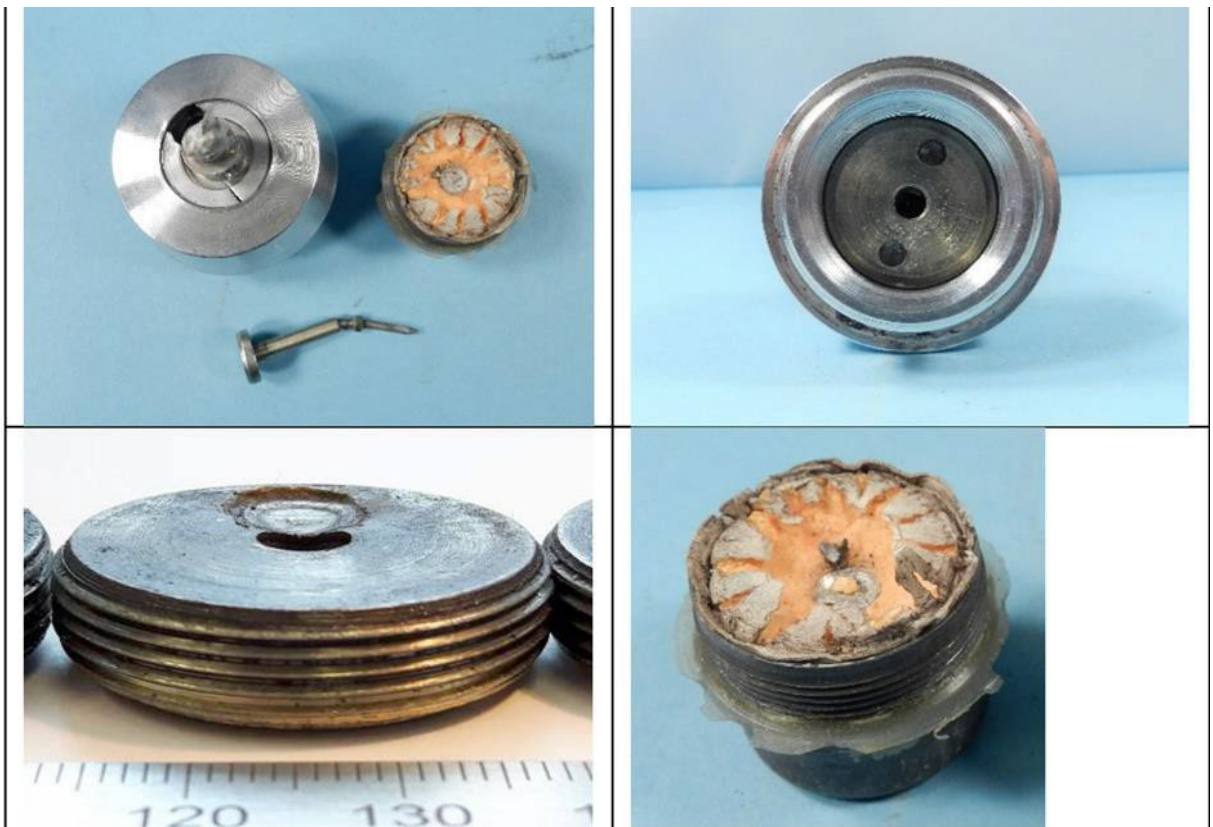
Figure 32: Pictures from TNO Explosives train interruption test, from top left, clockwise: impact fuze after the experiment; bottom surface of the barrier with debris of the lead charge cup; indentation of base of the lead charge cup in the booster charge; impacted interrupter plate with an indentation at the location of the duplex detonator. (Picture: TNO)
