DUTCH  
SAFETY BOARD

# Near mid-air collision between F-16 and Tecnam

*The Hague, October 2025*

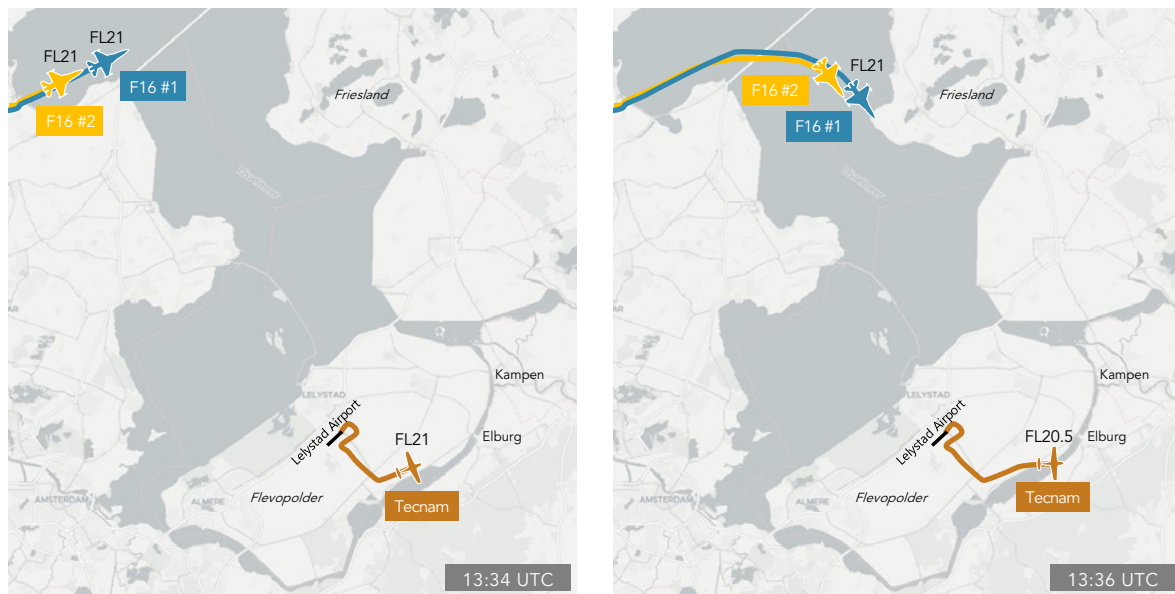
▲ Figure 1: Approximate aircraft positions at 13:34 and 13:36 (source radar data: ATC the Netherlands).

At 13:36, the area controller instructed the formation to climb to 3,000 feet due to VFR traffic flying in the area of Lelystad Airport and opposite IFR traffic. The opposite traffic was another F-16 formation that was scheduled to fly at 2,000 feet along the same route from Volkel to Vlieland. At the time of the area controller's instruction, this formation had not yet departed from Volkel Air Base.
