ONDERZOEKSRaad
VOOR VEILIGHEID

Mortierongeval Mali 2016

Heropening onderzoek 2022

Den Haag, augustus 2022

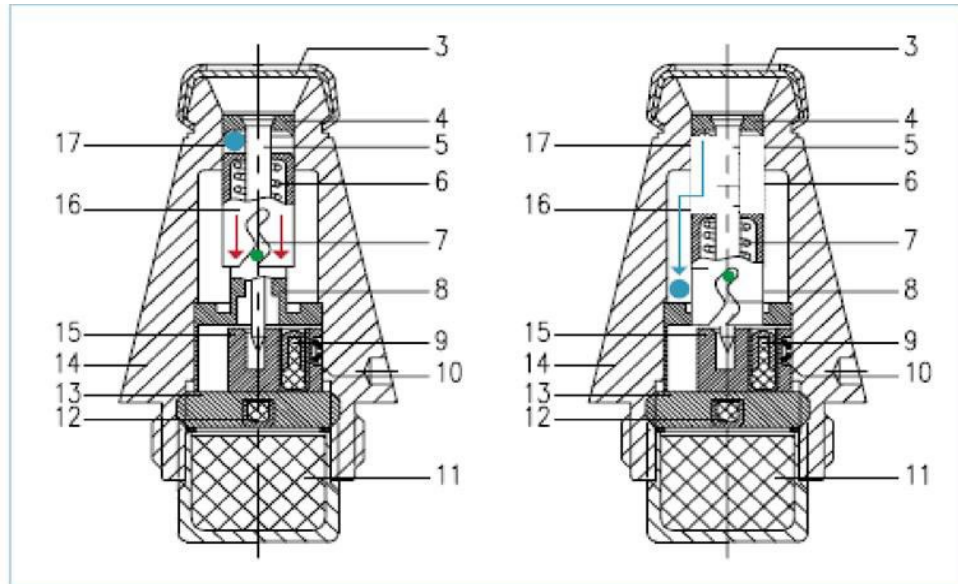
Figure 5: Position of the safety mechanism in the fuze at the moment before the acceleration begins, direction shown with red arrows (left) and at the end of acceleration at leaving the mortar tube (right). Cross pin (not numbered) shown in green. (Source: Ministry of Defence/TNO)

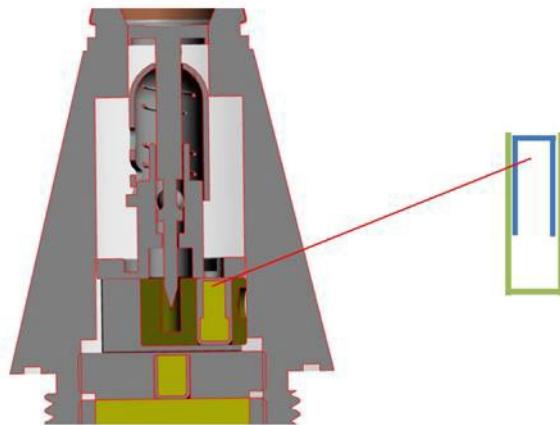
The detonator within the M6-N is a highly complex device in its own right which serves to transfer the stab/friction action of the firing pin, which causes ignition in the first stage to full detonation of powdered PETN in the detonator final stage. The vital intermediate function in generating the detonative, as opposed to the much slower, igniferous reaction, is performed by lead azide, a compound which was developed before the Second World War and still finds worldwide detonator application. The design and location of the detonator in the M6-N fuze is illustrated in Figure 12 where it will be seen the detonator consists of two metal caps. The inner cap, in intimate contact with the various chemical stages, is of aluminium whilst the outer one is of Melchior, a copper-nickel alloy. This design is entirely conventional and typical of stab detonators of the post-war period used by both NATO and Non-NATO nations. The complex explosive mixtures within it were largely derived empirically in wartime circumstances when large quantities of highly sensitive primary explosives were being processed; safe manufacture and reliable functionality were the priority. The level of scientific understanding expected in modern times was not a priority. In wartime and post war conditions, munition expenditure was so great that only relatively short service lives were required and ammunition was often sea dumped after overseas deployment. Use of empirically derived detonator compositions may still be necessary, particularly for simple, 'general munitions' such as mortar grenades but the

Figure 12: M6-N Fuze. The duplex detonator consists of two metal casings with one slid into the other. The inner casing that contains the energetic materials is made from aluminium. The outer metal casing is made from a copper-nickel metal alloy (Melchior). (Picture: TNO)

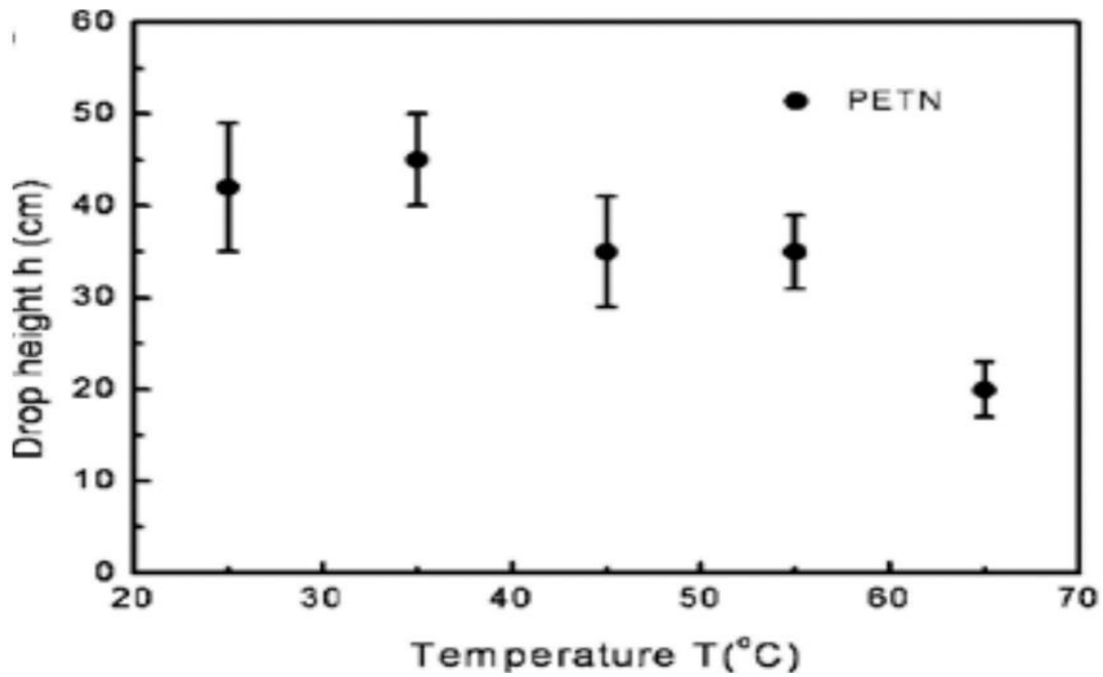
Figure 21: 7 Drop height at which PETN reacts versus temperature [Zhang & Weeks, 2010]. Note large increase in sensitivity above 55°C. (Source: TNO)

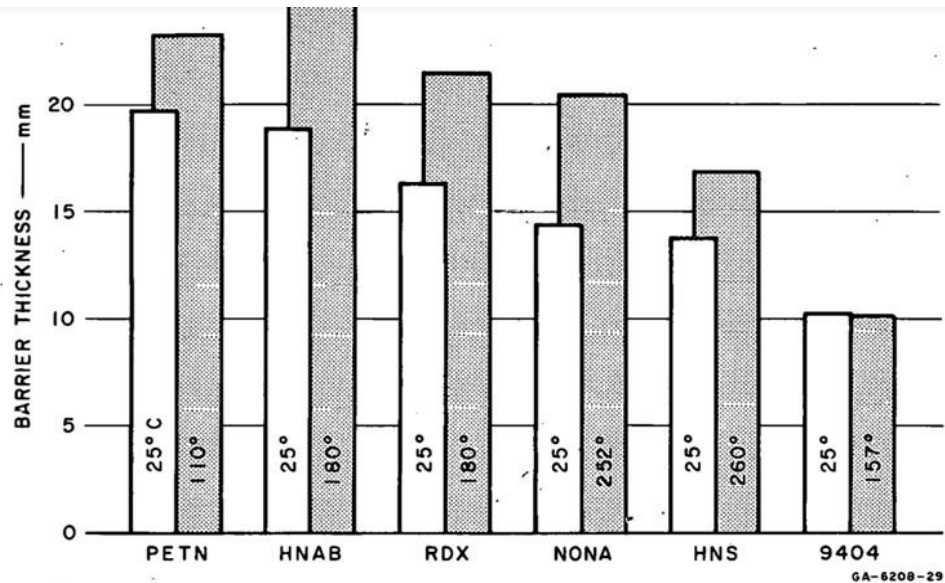
Figure 22: Shock Sensitivity of various explosives against temperature. Influence for PETN and RDX is of secondary order. (Source: Roth and Blackburn, 1967)

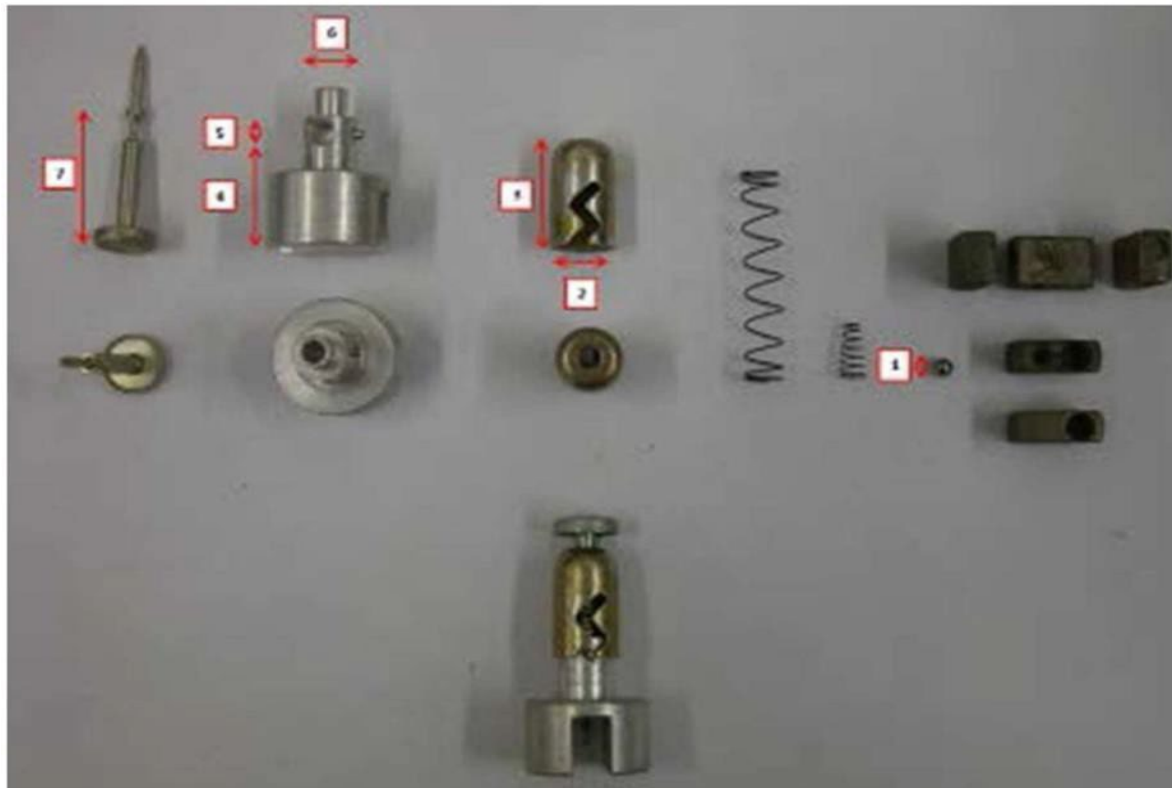
consideration of the fuze design (Figures 4 and 5) makes it apparent that very major dimensional deviations would make it impossible to construct the fuze mechanism. TNO state [7 Section 4]:

Figure 23: Fuse M6-N, Breakdown and dimensions measured by KC W&M. (Picture: KC W&M)

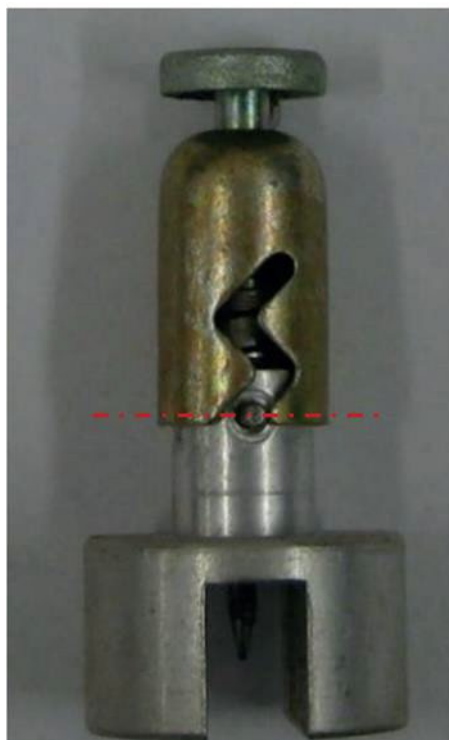
TNO carried out series of experiments and calculations concerning the safety of the mechanical aspects of the M6-N fuze [5, Appendix F]. The spring constant (Part 6, Figure 4) was calculated and also measured, although the difference was not great (144.7 N/m calculated versus 178.8 N/m experimentally) TNO used the experimental measurement as this included the rotational element imposed by the cross-pin movement along the zig-zag slot. Using this constant with the appropriate component weights, fuze and launch tube dimensions, physical and ballistic forces, TNO calculated the conditions necessary to arm the M6-N fuze. It is apparent that the design is competent to enable safe firing. For example, vertical drop of the mortar grenade

Figure 24: M6-N fuze mechanism composed of correctly positioned zigzag cross-pin at the beginning of the first “knee” of the zigzag slot (Picture: TNO)

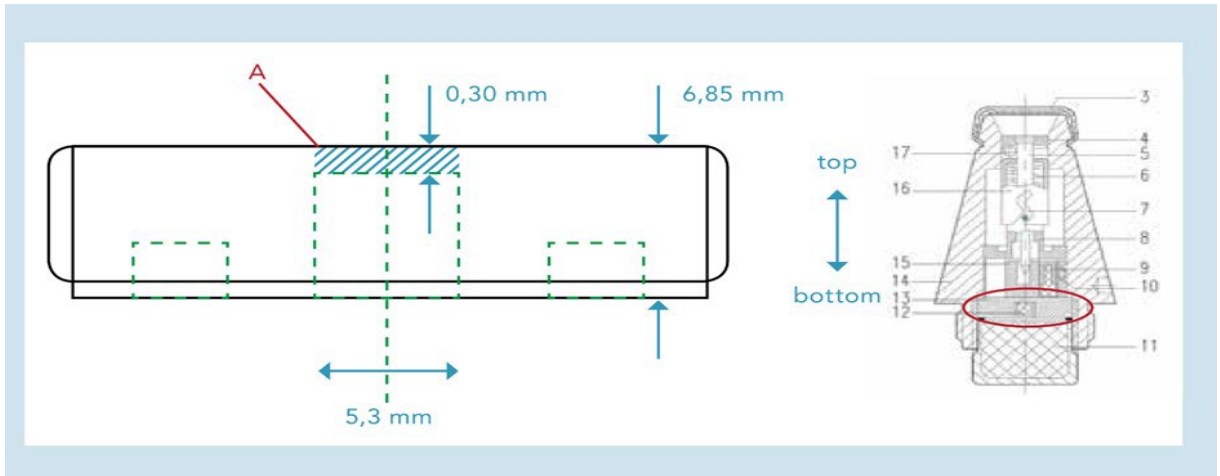
The author agrees that there is certainly a close resemblance between the interrupter plate attributed to the accident and that from external explosive demolition but does not consider the evidence supports the view that it could not have been generated by the accident. The accident involved detonation of around 200g of TNT in immediate proximity to (though still 'outside') the fuze. This detonation would have involved acceleration at high speed of steel fragments from the mortar grenade with the forward internal thread being in particularly close location (but separated from) the interrupter/cover plate. Figure 11 shows a fragment recovered from the mortar tube which has been deeply scored by the grenade centring rings. This serves to illustrate the degree of damage to steel components the detonation could create. It is possible (but not proven) that grenade fragments as well as mortar tube fragments or high-speed ground impact produced the damage to the interrupter/cover plate attributed to the accident. The same causes may also have produced the distortion noted in the external demolition; thus, explaining the similarity. However, whilst the author accepts that no evidence

An additional factor is important in considering the interrupter plate evidence; both the safe position experiment and the accident evidence plates show the detonator actioning has caused the lead/transfer charge to react and the steel which was above this charge has been swept away. The interrupter plate is shown in section (in Figure 31) and, as shown in Figure 30, it can be seen that a 0.3 mm section has been lost. This is contrary to the design intent and the interrupter plate has failed in its function. In the DSB proposed mechanism, this enables a detonation of unstable copper azide, caused by launch set back shock, to be transmitted to the lead/transfer charge which, in turn led to the booster and main charge detonation. This aspect of the evidence is discussed in detail in Section 6.8 below.

Figure 31: Cross-section drawing of M6-N explosive train interrupter plate showing location of 0.3mm steel swept away in Figure 30 plates. Location of plate shown (circled red) on drawing, right hand side. (Source: TNO)

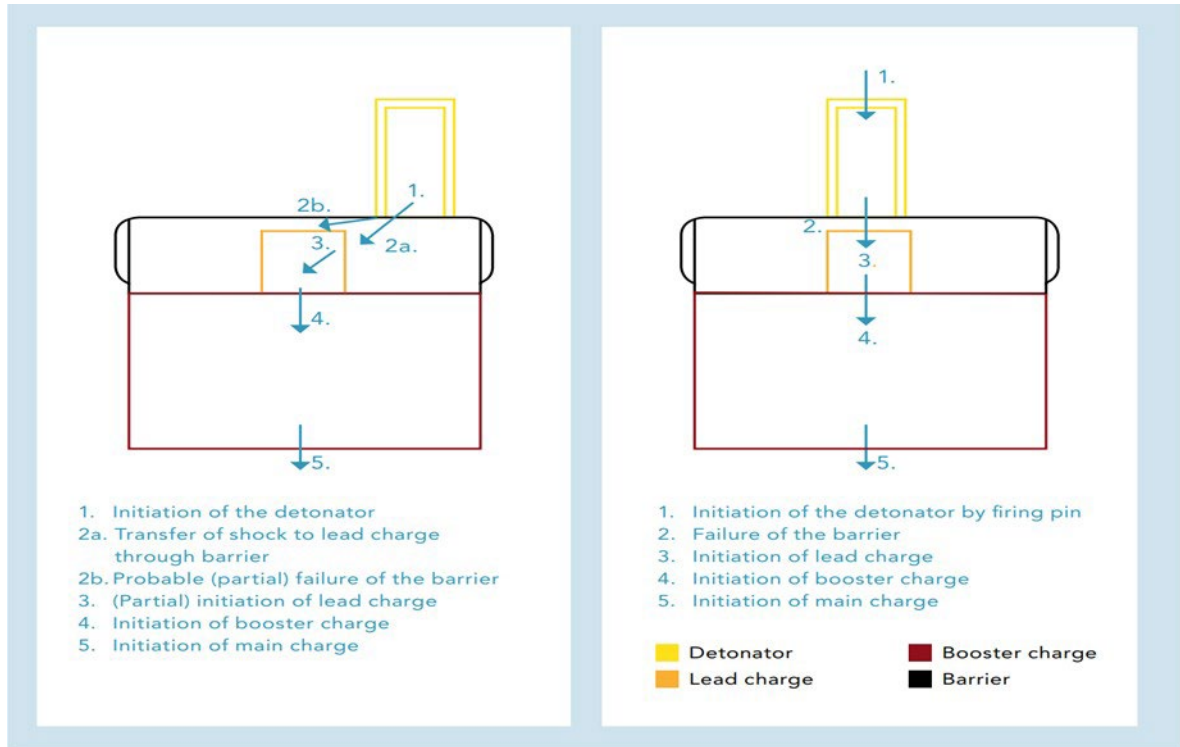
The failure to initiate the booster in the two TNO trials (carried out at 12°C) where a booster charge was fitted, and in a later single repeat trial carried out at 70°C [5, Appendix J] in closer emulation of the accident condition, causes reasonable doubt in the 'safe' position detonation mechanism (shown on the left-hand side of Figure 33). In contrast, every test of the M6-N fuze with the detonator in the armed condition produced full detonation of booster and main charge (where fitted) and there is no doubt from the photographic and physical evidence that the accident was such a detonation. To explore this issue further, KC W&M carried out 30

One possibility may be that the key variable is the extent to which the energy of the lead/booster charge is partitioned between deflagration and detonation. When the detonator is in the armed position (Figure 33, right hand side), the PETN booster is efficiently detonated, maximum shock energy is transmitted to the booster which detonates in turn. Where the

Figure 33: Explosive train for an unarmed fuze (left) and an armed fuze (right). (Source: TNO)
