TNO report**TNO 2016 R10735****Investigation into a Periodic Technical
Inspection test method to check for presence
and proper functioning of Diesel Particulate
Filters in light-duty diesel vehicles**

Project name In use compliance program for light-duty vehicles

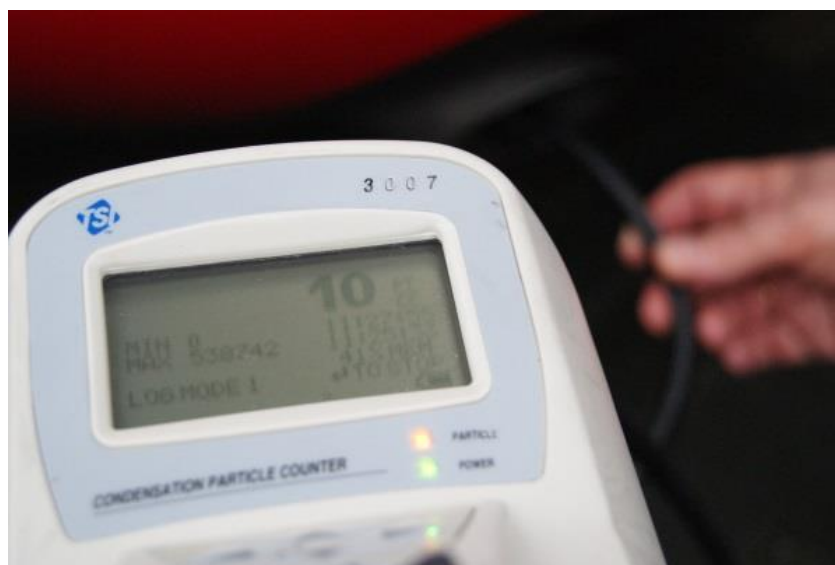
Figure 6 The sample hose was kept in the exhaust pipe until the read-out stabilized.

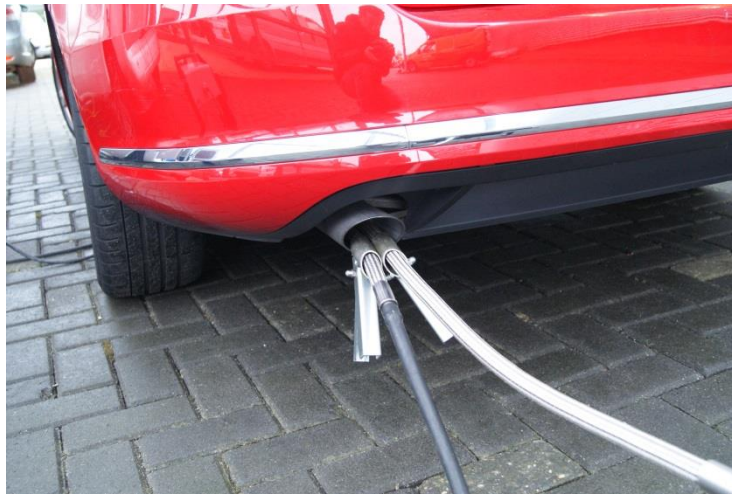
Figure 9 The probes of the LPA and EDA2 opacity meters were both inserted into the tailpipe during the free acceleration test and the high idle speed test. This way, both smoke meters measured simultaneously. Also see Figure 4.

In the free acceleration test, the probes of both smoke meters were inserted into the tailpipe, in line with the exhaust flow (Figure 9). It is assumed that both meters are charged with equal exhaust gas mixture.

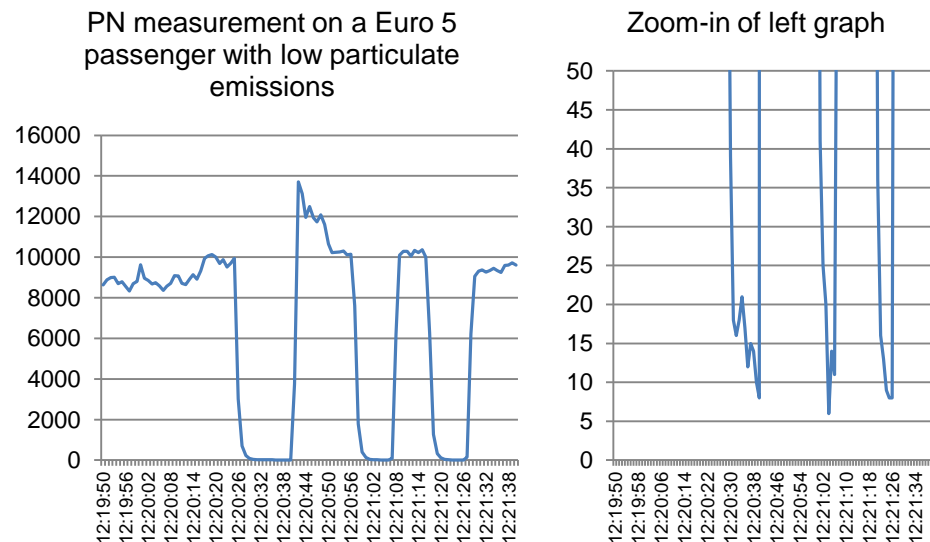
Figure 15 PN measurement on a Euro 5 car showing low particulate emissions. The graph shows that the ambient concentration was around 9,000 to 10,000 particles per cm^3 . The three minima unmistakably represent the tailpipe measurements. Zooming in on the left picture shows the particulate emissions are as low as 6 to 8 particles per cm^3 .

Figure 15 is a typical example of a PN measurement on a low-emission vehicle. As can be seen in the figure, the PN counter first reports a background concentration of around 9,000 particles per cm^3 . Upon insertion of the sample hose, the number of particles starts to drop significantly. As little as 6 to 8 particles per cm^3 were found.

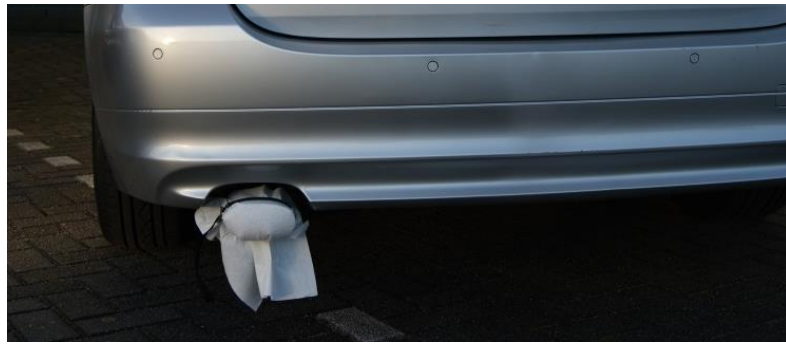
Figure 16 In the tissue filter test, a tissue was attached to the end of the exhaust pipe after which the engine was let running at idle speed for three minutes. Cars showing elevated emissions in previous tests were selected for the TFT.

Vehicles scoring 3 on the tailpipe swipe test and showing high opacity values and/or high PN emissions were selected for a tissue filter test. A tissue was attached to the end of the exhaust pipe, as can be seen in Figure 16, after which the engine was let running at idle speed for three minutes.

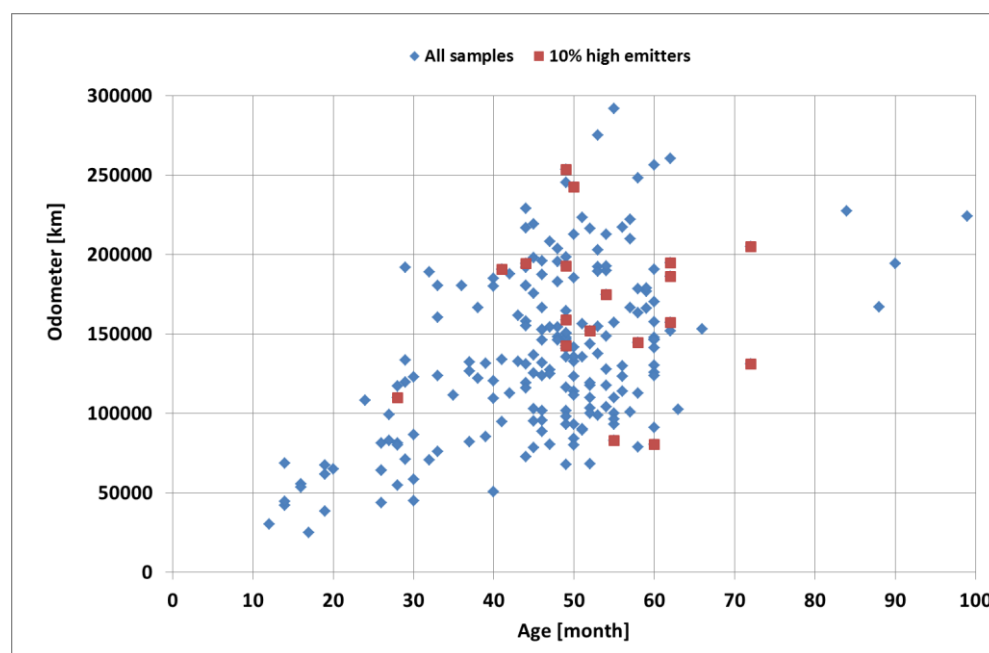
Figure 19 Age and odometer readings of the tested vehicles.

In Figure 19, the so-called 10% high-emitters are shown in red. Based on a Particulate Number (PN) emission of more than $250,000 \text{ \#/cm}^3$, the 10% 'highest-PN vehicles' were identified. As can be seen, most of the vehicles with high PN numbers are 4 to 5 years old, with a mileage between 130,000 and 190,000 km.

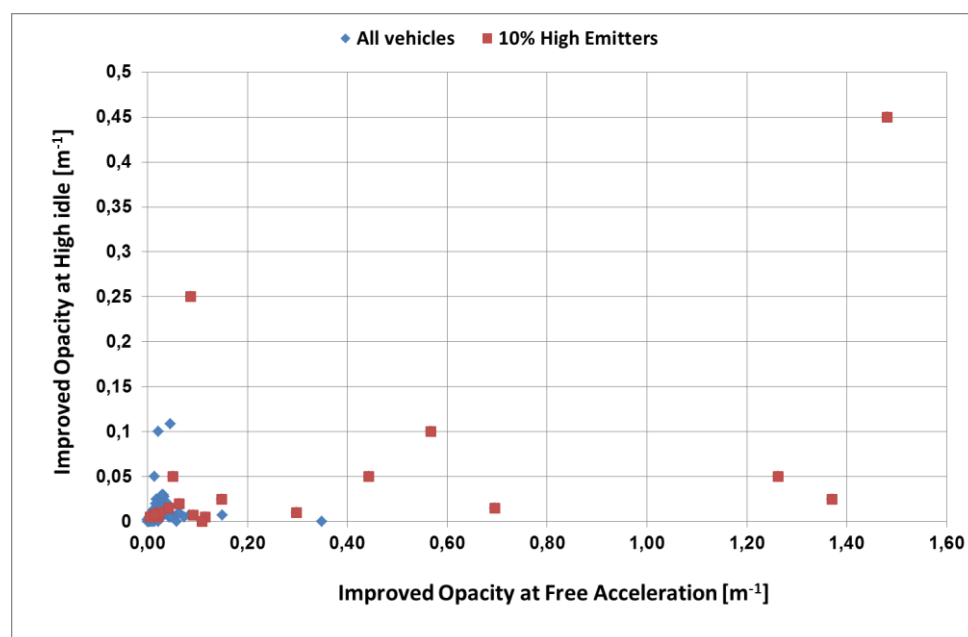
Figure 23 Improved opacity results in free acceleration and high idle speed tests.

Figure 23 plots free acceleration versus high idle speed smoke test results. No clear correlation between these two test types exists.

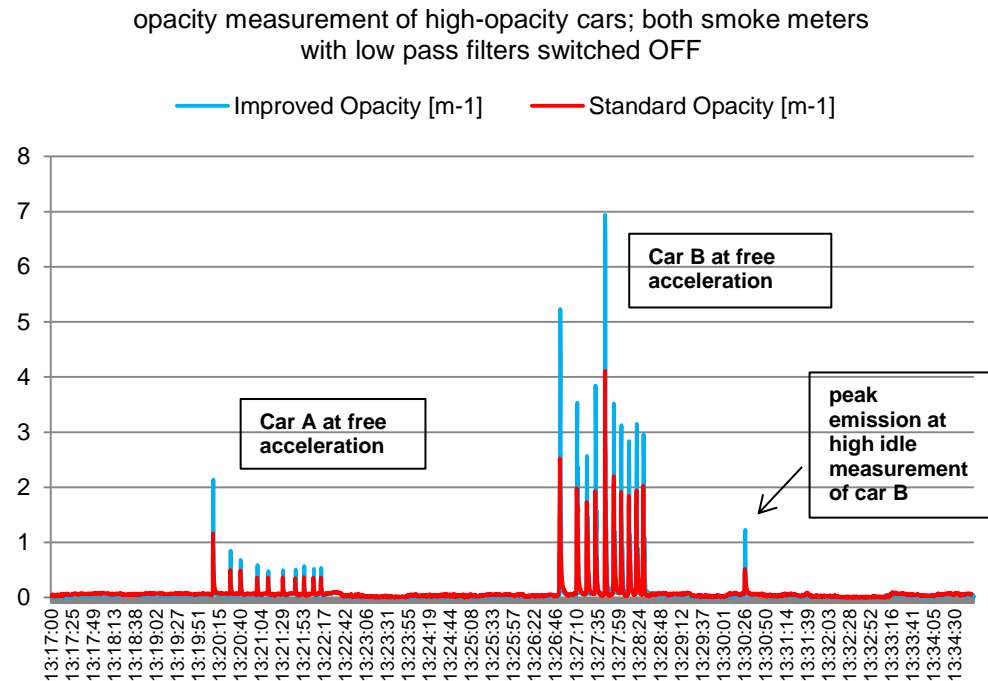
Figure 31 Results of opacity measurement of two cars with high smoke values, using the standard opacity meter and the improved opacity meter, both in the *unfiltered* mode.
